11. TITLE (Include Security Classification) Mechanical Reliability of Piezoelectric and Dielectric Ceramics			PROGRAM ELEMENT NO.	PROJECT NO.
			TASK NO.	WORK UNIT ACCESSION NO.

Mechanical Reliability of Piezoelectric and Dielectric Ceramics

ELECTRIC FIELD EFFECTS ON SUBCRITICAL CRACK GROWTH IN PZT

CRACK PROPAGATION IN Z5U MULTILAYER DIELECTRICS

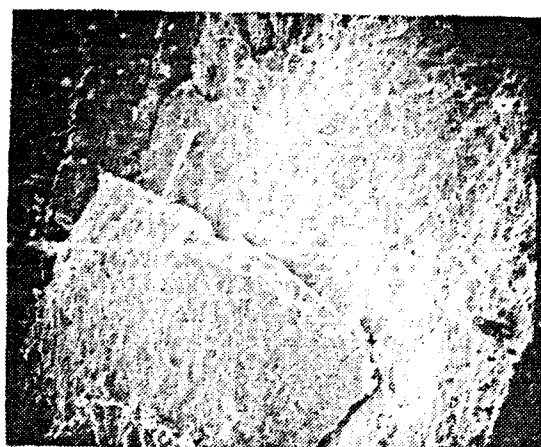
Figure 5: Fracture Surface Indicating Large Delamination and Underlying Crack

Upon examination of the fracture surfaces, a variety of very large defects were discovered. Examples of these are shown in Figures 5 and 6. In Figure 5, the fracture origin for this particular sample is seen to be a large delamination (several hundred microns in size). The sample shown in Figure 6 fractured along an electrode/ceramic interface. The origin of fracture was determined to be the inhomogeneous zone contained within the electrode layer as shown in Figure 6. EDAX identified a high concentration of potassium and chlorine in this region.

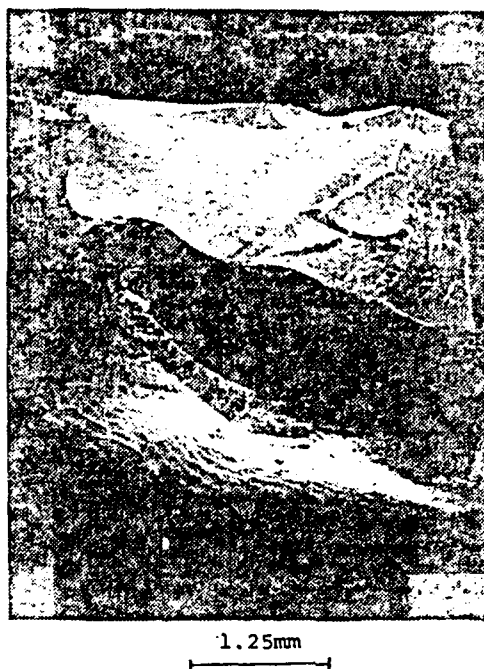
Figure 6: Scanning electron micrograph of fracture surface of Z5U multilayer capacitor indicating fracture origin at site of interfacial delamination.

In summary, the mechanism(s) of failure and the characteristics of the fracture process (e.g. delamination) in multilayer ceramics differ from those observed in the bulk form. The differences are primarily due to a combination of structural anisotropy and elastic anisotropy.
